**NIOSH/MSHA Testing of the four Biomarine,
Biopak 240S, Closed-Circuit Self-Contained
Breathing Apparatus (SCBA) involved in the Storm
Decline mine fatalities and rescue efforts**

**NIOSH/ National Personal Protective Technology Laboratory
MSHA/ Pittsburgh Safety and Health Technology Center**

April 3, 2003

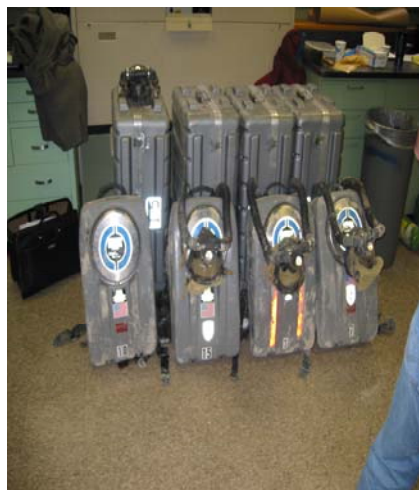
- All observations were recorded. Units and original packaging were retained as evidence and remained in MSHA's custody throughout.
 - Figure 1a, Appendix III, is a photograph of the units after unpacking.

Figure 1a (From left to right) Apparatus #10, #15, #1 and #7.

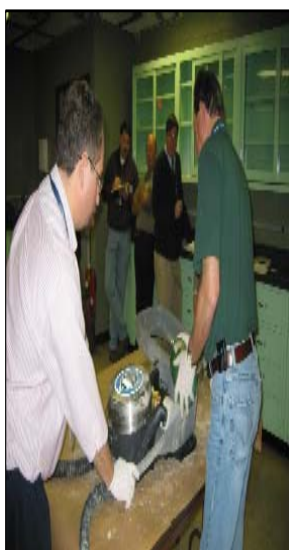
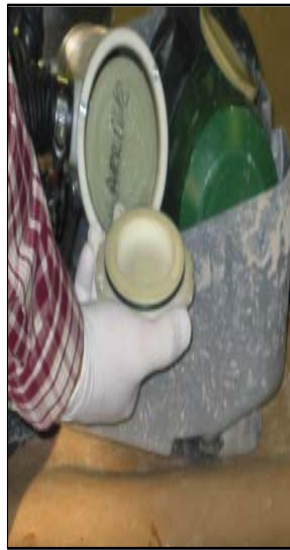
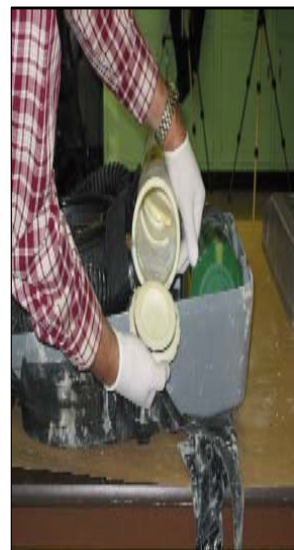
Figure 4a: Restoration process

- Figure 4a, Appendix III, is a photograph of the restoration process.

- Spreadsheet 4a, Appendix III, summarizes the findings of the visual inspection that took place during the restoration.
 - Figure 4b, Appendix III, is a photograph of Apparatus #10, showing a Gel Tube installed in the coolant canister.

- Figure 4c, Appendix III, is a photograph of Apparatus #1, showing that the coolant canister is empty and no Gel Tube is installed.
 - In addition, samples of the scrubber material were collected and analyzed.

Figure 4b: Apparatus #10 with GelPak missing

Figure 4c: Apparatus #1 with GelPak installed

- ❖ The findings of nonconformance are listed below:
 - As received from the mine, Units #10 and #15 did not have Gel Tubes installed. Use without a Gel Tube does not conform to conditions of approval.

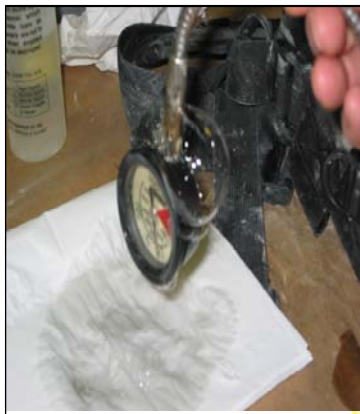
- Since the chest gauge on Apparatus #15 was found to be leaking, it was replaced with a new one. Figure 6a, Appendix III, is a photograph showing the leak at the chest gauge. The leak rate for chest gauge was quantified at about 243 ml/minute.

- It should be noted that, on Apparatus #15, the leak previously identified as being associated with the chest gauge was, in fact, located at the point where the gauge was connected to the flexible hose.

- Evidence pointing to the gauge connection was the presence of water deposits on the chest gauge O-ring seal, as well as direct confirmation that the gauge worked properly.

Figure 6a Leak at chest gauge on Apparatus #15

Note: "T" connection tightened with a 1/2
 turn Chest gauge replaced with a new one

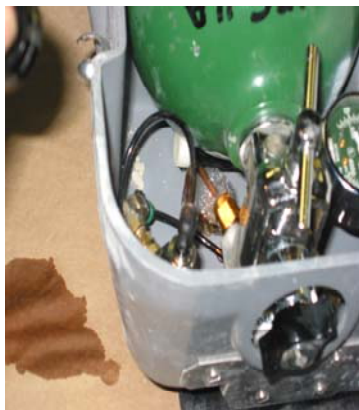
- In addition to the leaky gauge, another leak was discovered in Apparatus #15 at a T-connection during the high-pressure leak test. Figure 6b, Appendix III, is an engineering drawing identifying the

location of the leak at the T-connection. Figure 6c, Appendix III, is a photograph of the T-connection leak.

Figure 6c Leak at T-connection on Apparatus #15
